Investigation Techniques Carried out on the Qutb Minar, New Delhi, India

ABSTRACT: In the framework of the Eu-India Economic Cross Cultural Programme “Improving the Seismic Resistance of Cultural Heritage Buildings”, aimed at the preservation of ancient masonry structures with regard to the seismic risk, different NDT were applied to the Qutb Minar, New Delhi, India, in September 2005. The paper describes the different investigation techniques applied (Ambient Vibration and Pulse Sonic Velocity Tests), intended to define the dynamic response of the tower and to qualitatively define the masonry conditions. For the dynamic modal identification analysis different test equipments were used, in order to compare the data and to have more reliable results. The dynamic parameters resulted from the acquisition campaigns will be used to estimate the mechanical properties of the masonry walls and the boundary conditions of the structure, to be considered in successive seismic nonlinear analyses of the Qutb Minar, aimed at the assessment of the safety level of the construction.

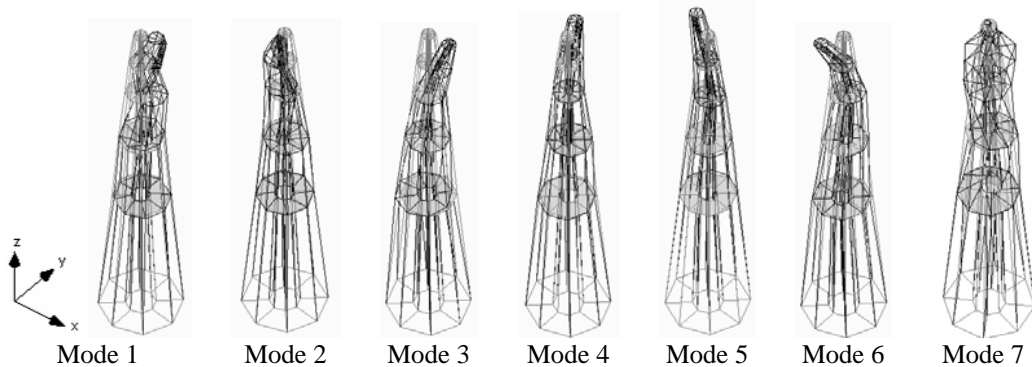
The maximum level of vibration measured on the top of the Minar was lower than 2.5 mg. The 9 data series acquired at 100 SPS (Samples Per Second) were then processed by a decimation of 5 (Nyquist frequency of 10 Hz), with segment length of 516 points and 66.67% window overlap, with 3 projection channels for the subspace identification. 20 structural modes and 30 noise modes were considered for the stochastic estimation of the models. Concerning the frequency results, Table 2 summarizes the experimental values for both of the analyses. The estimated corresponding frequencies, arising from the two methods, are very similar, with an error less than 2%. The closest frequencies are related to the first two modes, with values of 0.79 and 0.81 Hz. Figure 5 shows a perspective view of the defined mode shapes. Ten bending, two torsional, one axial and one undefined mode shapes were estimated. It is stressed that the two first bending modes were not clearly defined at the top, especially at the fourth balcony (Level 4).

Figure 5 : Perspectives of the first seven mode shapes (UPC method).

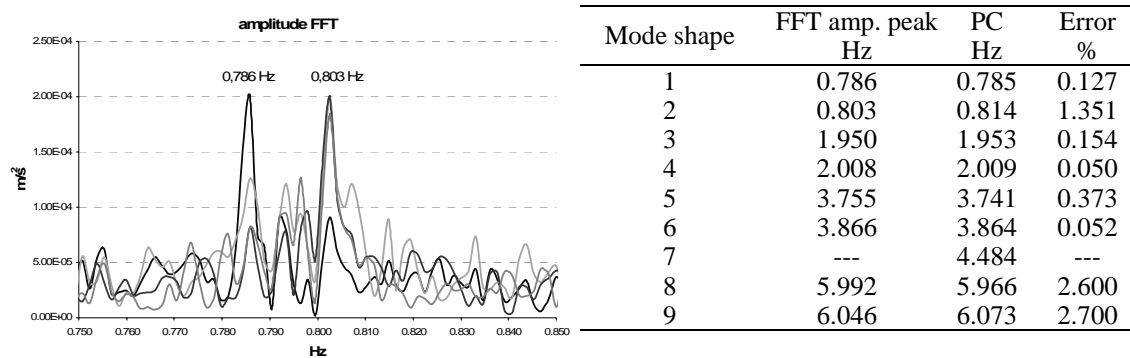
sition system. Eight piezoelectric acceleration transducers with the same characteristics respect the first acquisitions were used, connected to a module provided with 24 bit A/D converter acquisition card. A sampling rate of 100 SPS was considered, with a total of 65,536 points acquired. In this case, a single amplitude peak FFT on the complete set of points was performed. The visualization of the FFT function in correspondence of the first resonant peaks and comparative results in the frequency domain respect the first 9 frequencies identified by University of Minho (PC method) are provided in Figure 7. A good match between the obtained frequencies can be noticed (maximum error equal to 2.7%).

Figure 7 : left: amplitude FFT, first resonant peaks, related to the two first mode shapes individuated; right: comparative frequencies results, different acquisition systems.

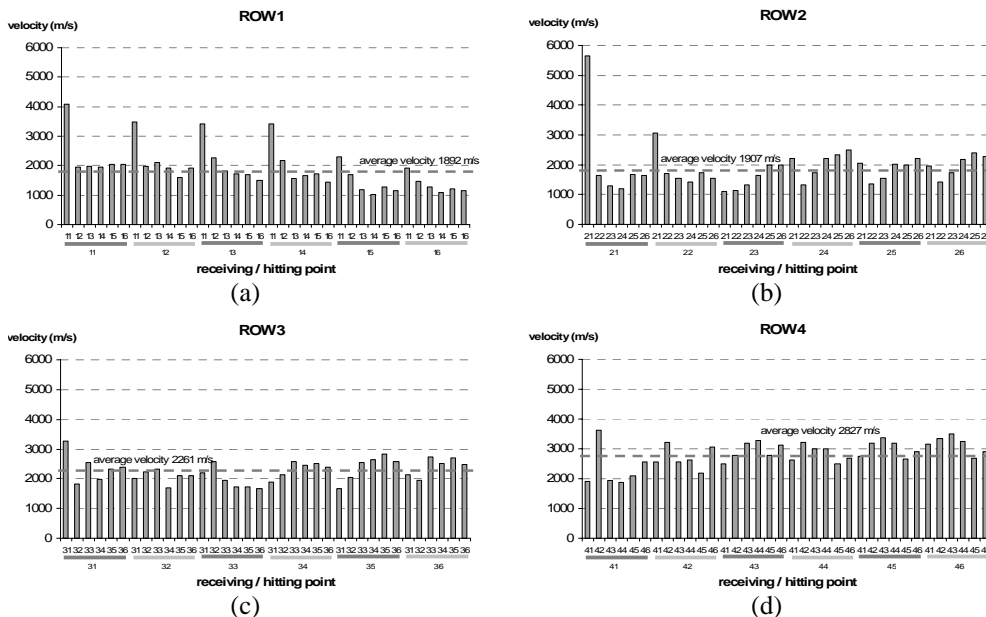
Test consisted in hitting with the instrumented hammer one side of the corner (the West side). On the other side six acceleration transducers were placed simultaneously, recording only the paths relative to a given row. Hence, per each row (horizontal plane), thirty six paths were recorded (Figure 8c). The overall average velocity value corresponded to 2222 m/s, and the minimum velocity value found was 1017 m/s. Noticeable velocity variations were encountered on the paths supposedly crossing for a big part the internal rubble masonry infill respect the ones referable to the “corner” paths. In correspondence of the paths relative to the closest points to the corner (i1-i1, $i = 1$ to 4), at different heights, the highest velocity values were found, not too far from the velocity found in the red sandstone sample. Also, an increasing sonic waves velocity was noticed from the 1st to the 4th row, being the average row velocity values (from the 1st to the 4th) equal to 1892, 1907, 2261 and 2827 m/s respectively (Figs. 9a, b, c, d).

Figure 9 : Velocity histogram, sonic paths, (a) 1st to (d) 4th row.

Considered the fair velocity values encountered, it seems reasonable to hypothesize that no remarkable size voids within the tested masonry or major detachments between the external veneer and the infill are present.
