## The Antiseismic Rehabilitation of Marchesale Castle at San Giuliano di Puglia

**ABSTRACT:** After the earthquake (October 31<sup>st</sup>, 2002) which struck Molise Region (Italy), an ENEA team has been collaborating to the reconstruction of the town of San Giuliano di Puglia. Many buildings suffered severe damage or partial collapse, including important Masonry Cultural Heritage Structures (MCUHESs). This paper specifically deals with the rehabilitation of the notable Marchesale Castle, in the framework of the ENEA scientific advice given to the Office of the Public Works Ministry. ENEA reviewed in detail the rehabilitation project (entrusted, as other works, to private consultants), suggesting some remedial actions.

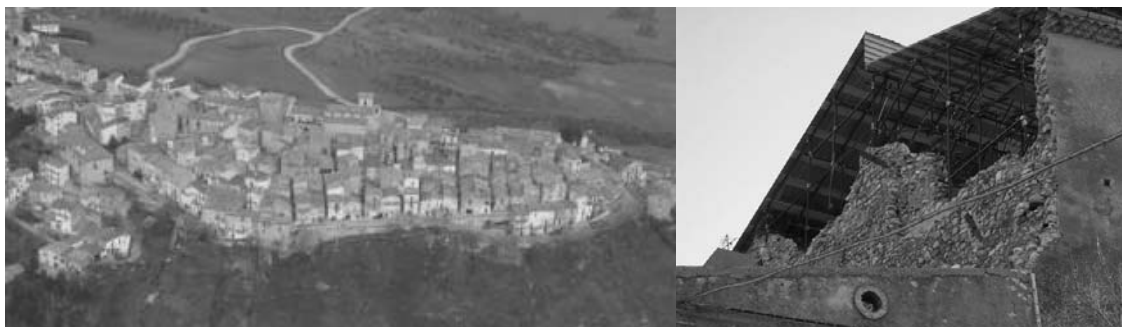
Figure 1 : View of the San Giuliano historical center.

Figure 2 : Damage to Marchesale Castle.

The medieval center (Fig. 1), interesting from an historical and architectural point of view, was deeply investigated; in spite of the low local amplification, it presented partial collapses and a medium-severe damage; only a few houses were ready for reuse. Also the more notable MCUHESs (including Marchesale Castle, Fig. 2) suffered heavy damage. All the area was in general characterized by high vulnerability and the most usual collapse mechanisms were the wall failure with typical cross cracks, but also out-of-plane overturning (Indirli et al. 2004a, b).

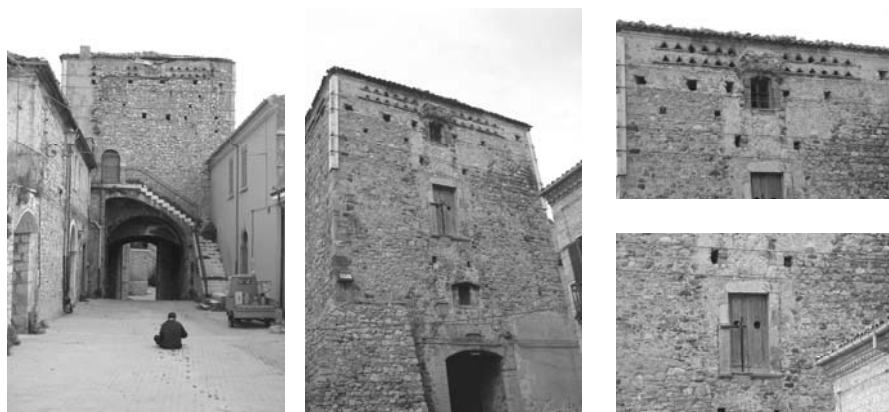
Figure 4 : The old Castle Tower.

The Castle is a typical example of the South Italy historical architecture. Its multi-leaf stone-masonry walls, which suffered medium-high seismic damage, are characterized by poor materials, irregular morphology and voids presence, often concentrated in a loose internal core. Many researches (Tomažević 2004, Modena 2004) focused the attention to the causes of the main structural problems (weakness of the internal layer, mortar deterioration in the external joints, lacking of connections among external leaves). In fact, these buildings are very sensitive to “brittle” collapse mechanisms, usually happening both under vertical and horizontal loads, by layers detachment and out-of-plane expulsions. The castle structure consists in several blocks interconnected together (Fig. 3). Taking as reference the castle internal court ground, four upper and three lower levels envelop the hill slope. The tower (Fig. 4) represents the most precious and ancient element of the entire complex. It is a squared-plan building, with buttresses on the West side and a Southern entrance portal (with a barrel vault) to the internal court. The tower upper quarters, covered by cross vaults, can be reached through external stairs. Most of the castle horizontal structures are generally wooden or steel-tied floors, but other original stone vaults, with different geometries, can be found at the lower levels (Fig. 5). The tower thick basement (until 2.90 m) shows a pronounced tapering with height (until 1.20 m), and an irregular masonry fabric is clear in the façades, made by heterogeneous materials (mainly corner squared stones, variously sized river pebbles and brick insertions), likewise the majority of the castle walls. In the tower front views it is still possible to identify pretty genuine architectonic evidences, the so

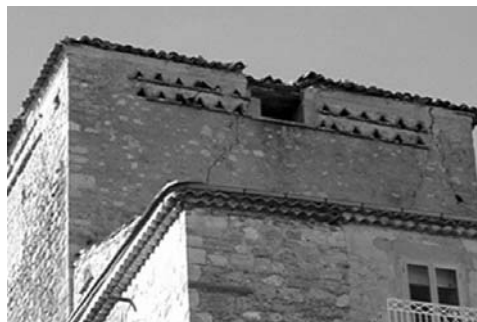
Figure 6 : Earthquake damage to the tower.

called “buche pontaise” (small holes used to provide supplemental defense wooden scaffoldings) and the twice-line triangular pigeon houses located under the roof (Fig. 6). Other aspects are: generally deteriorated mortar courses, plaster traces, brick fillings (old openings and masonry past rehabilitation). After the seismic event the tower free top was tied up with steel cables (in order to avoid overturning collapse) and covered by a steel sheet.

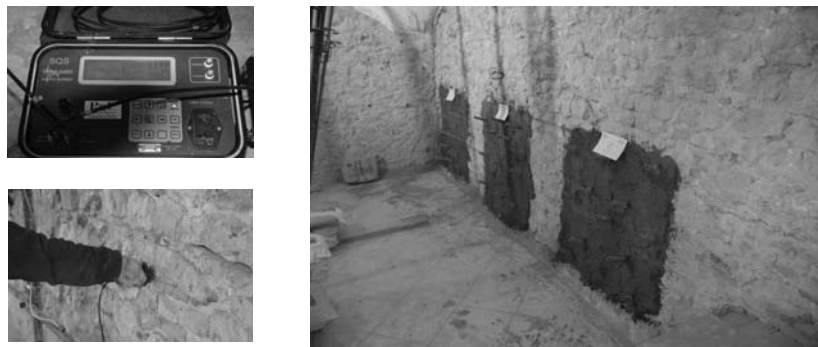
Figure 11: Sonic (left) and absorption (right) tests.

Sonic pulse velocity tests (Fig. 11), based on the generation of sonic/ultrasonic impulses at a point of the structure, are useful for different purposes, i.e. to qualify the masonry through the investigation of the wall section morphology, detect the presence of voids, and find crack and damage patterns. These tests have been performed widespread in all the Castle. In particular sonic tests have been carried out before and after absorption test to check repair effectiveness after mortar grout injections.

Absorption tests have been used to compare two different products for mortar injections, aimed to set up the main consolidation process parameters (e.g. pressure and time of the injection and number of injection holes). The tests (Fig. 11) have been performed on a representative building masonry portion. Subsequently mortar injections, sonic tests and boreholes with video endoscopy have been carried out, in order to check the quality of the consolidation process (demonstrated by a significant increase of mortar sonic velocity: 600 m/s ante injection, and 1300 m/s post injection).
